Historic Structure Report

Rangers' Club

Yosemite National Park
Yosemite Valley, California

George S. Jaramillo, Historical Architect
History, Architecture, and Landscapes Branch
Resources Management and Science Division

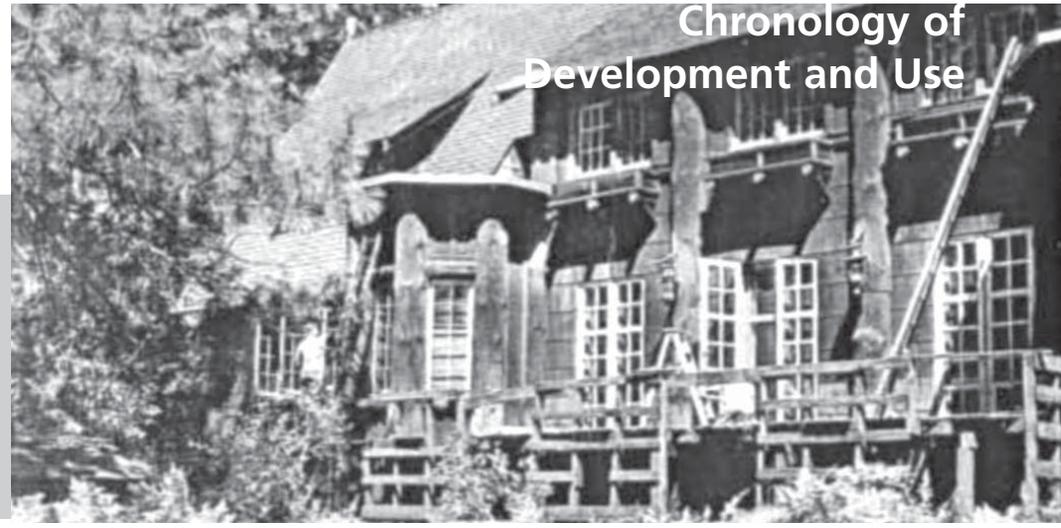
1953 Reconstruction of terrace - Note replacment of large cedar log columns

The mid-fifties saw the Rangers' Club received repairs to its exterior. Park management repaired the large southern terrace by replacing and repairing deteriorated and damaged material. This included removal of the entire wood deck repairing the substructure, the wood deck, railing, and log trim detailing. The deck was replaced with two-inch tongue and groove wood decking. The roofing at the south-facing bays, specified as galvanized iron in the original construction documents, was replaced with a built up tar and felt surface. The roof shingles on the remainder of the structure were sprayed with graphite and linseed oil. Rockwool insulation was added to the attic.⁸

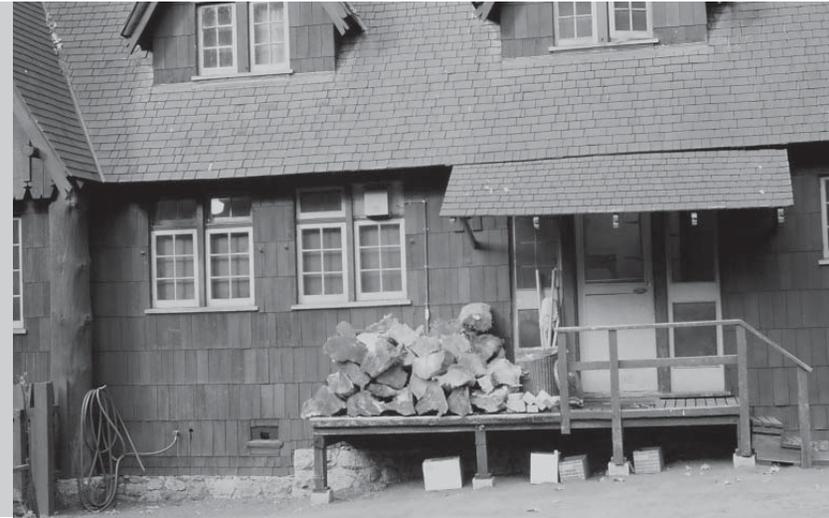
1970s Service porch with deterioration

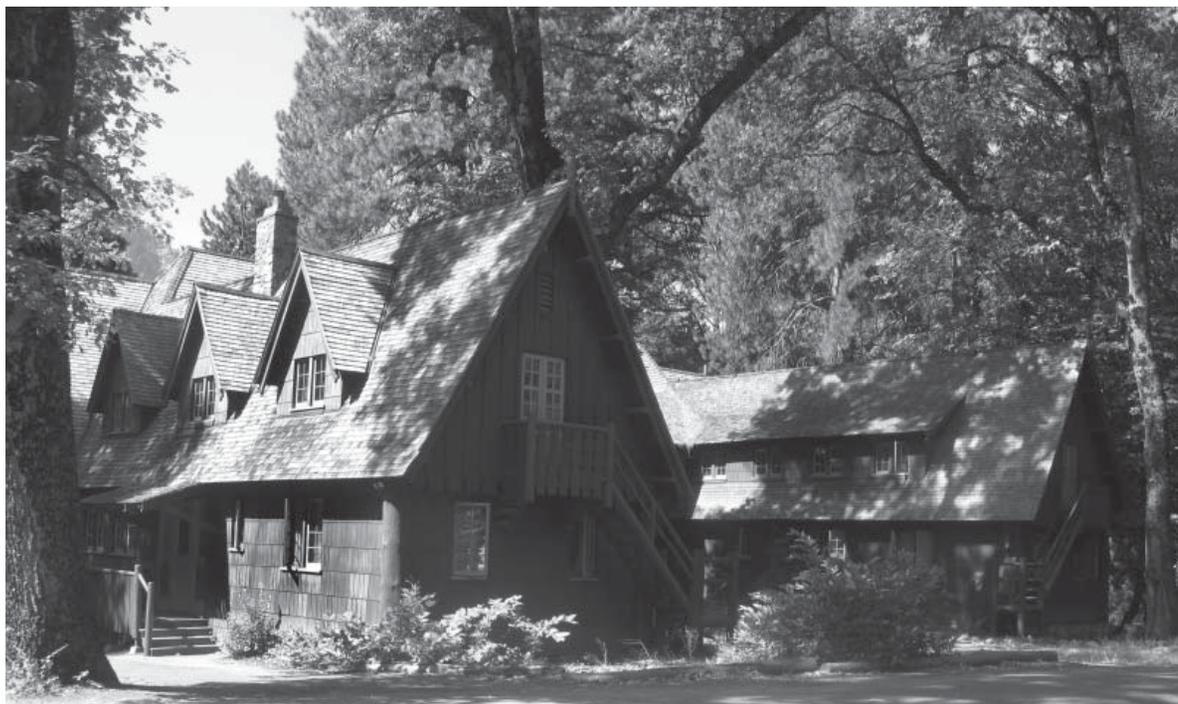
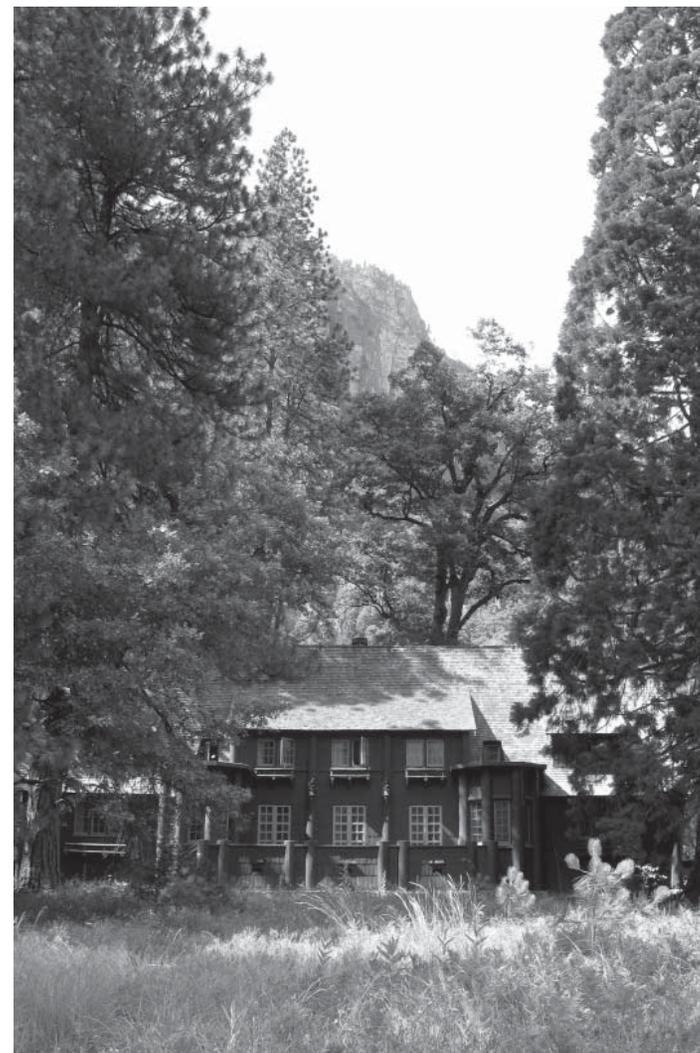
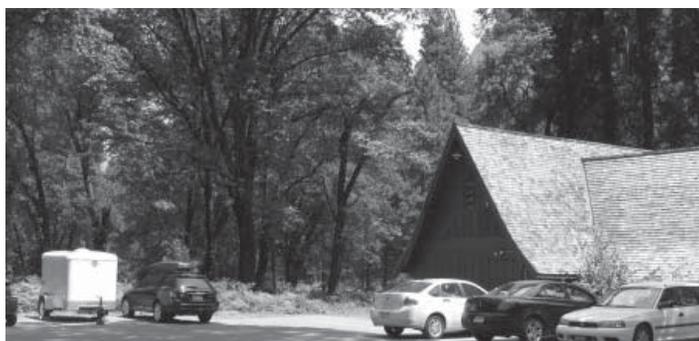
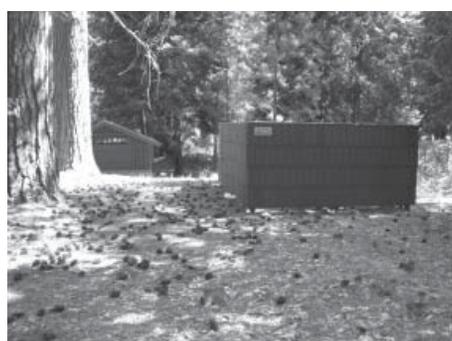
Overall, the site is in fair condition. Much of the evident deterioration on the site stems from inadequate maintenance and upkeep. Trash is strewn around the site.

The area between the garage and the clubhouse is poorly maintained. There are remains of storage items and garbage. The barbeque grill is rusting. The large storage units have paint peeling from them and do not seem to be used. The large recycling dumpster is being propped up on rocks and logs. Behind the garage old parking signs are rusting and old chairs, benches and stumps lay amongst the grass. The north end of the fence is partially collapsed and other sections have peeling paint.

The parking lot is poorly laid out. Inconsistent parking spaces allow improper parking conditions. Deteriorated asphalt has created potholes and tripping hazards. A similar condition exists on the asphalt path to the main entrance. The half round logs along the northern edge of the lot are also deteriorated, but this is expected due to their exposed nature. The National Historic Landmark sign is warped and scratched.

Tree and vegetation encroachment is evident throughout the site, particularly along the service entrance and the south deck. Furthermore, many of trees around the clubhouse are overgrown and in need of trimming and dead branch removal. The duff layer is quite extensive creating a fire hazard particularly on the southern and western sides of the site. The roots of the giant sequoia are exposed increasing the possibility of damage to the tree.

Figure 6.3, clockwise from top: North view into courtyard, south terrace, high voltage lot with transformer beyond, parking lot (Jaramillo, Summers, 2009)

1. Remove duff and reduce other fuel around the building to reduce fire danger.
2. Clean up garbage and remove old and rusting items from and around the site.
3. Repair and paint fencing. Replace any rotted or damaged boards in-kind.
4. Repaint exterior storage units.
5. Trim trees away from building.
6. Repair deteriorated pavement to remedy tripping hazards.

1. Resurface the parking lot. Consider use of permeable paving material.
2. Monitor giant sequoia tree. Consult with arborist to effectively address soil compaction.
3. Remove parking signs from the rear of the garage, after review/approval from Roads and Trails.
4. Consider removal/replacement of exterior storage units

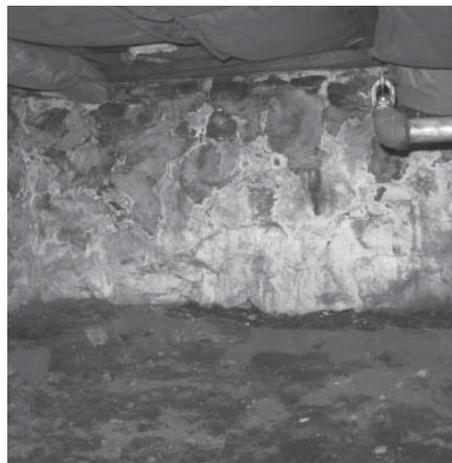
Figure 6.6, clockwise from left: Foundation stone pier footing and post, reinforced foundation, existing stone foundation with efflorescence, note moisture on ground (Summers, 2009)

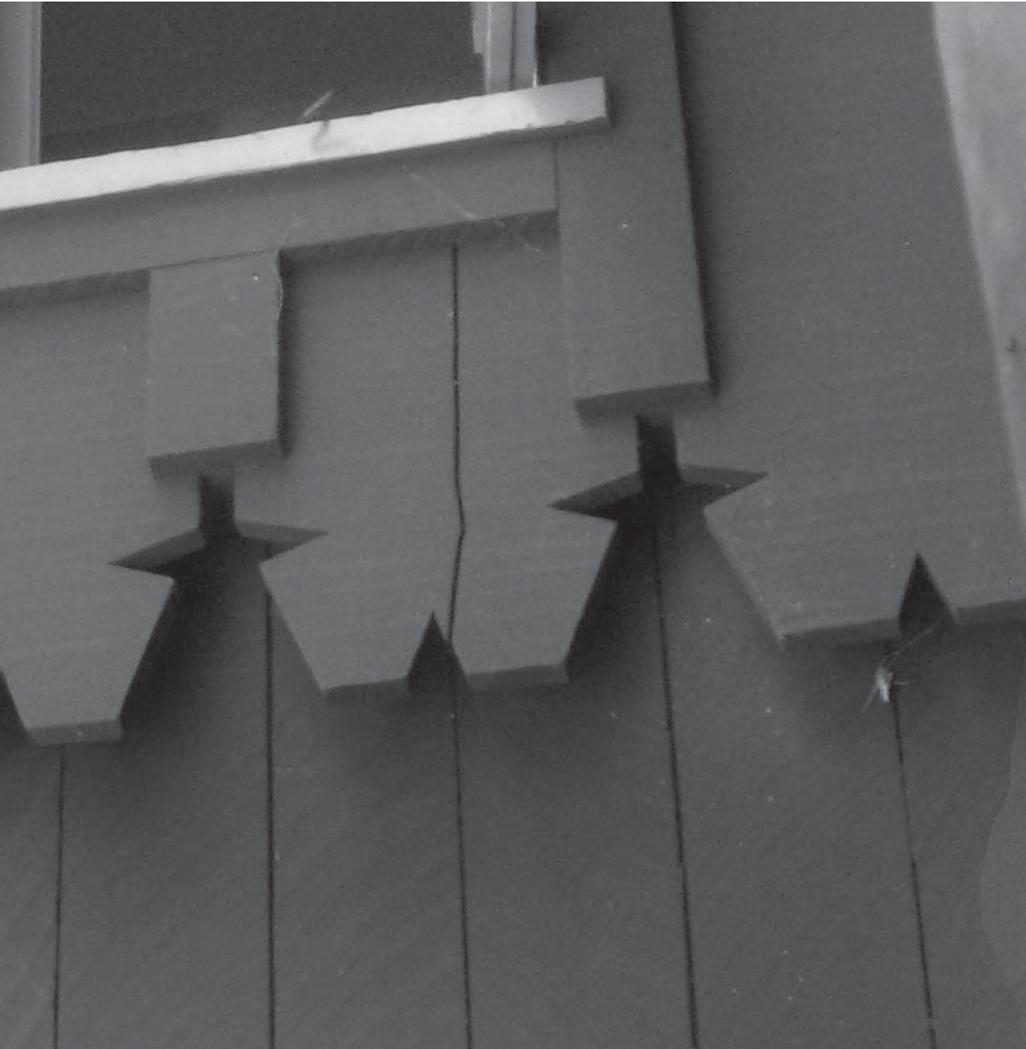
Figure 6.9: Split board on courtyard facade of clubhouse (Summers, 2009)

The board and battens are in fair condition. There is minimal evidence of checking or paint peeling, except on the south and west elevation. The bases of the boards have chipped sections of wood on the east and south elevation. There is uneven painting of the boards on the south elevation.⁵

1. Clean any animal droppings from all exterior surfaces.
2. Repair deteriorated bases of log columns, using care to protect intact historic fabric.
3. Repair or replace in kind missing and damaged shingles.
4. Repair chipped boards, replacing material in kind if necessary. Care must be taken to preserve historic scrollwork detailing.
5. Repair damaged planter boxes.

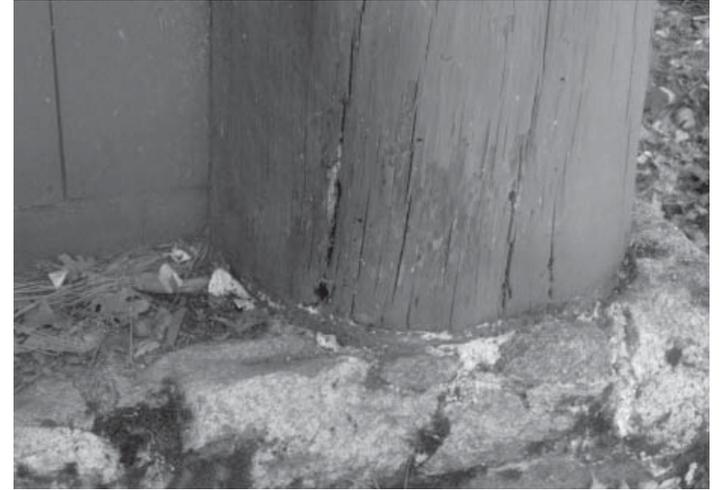
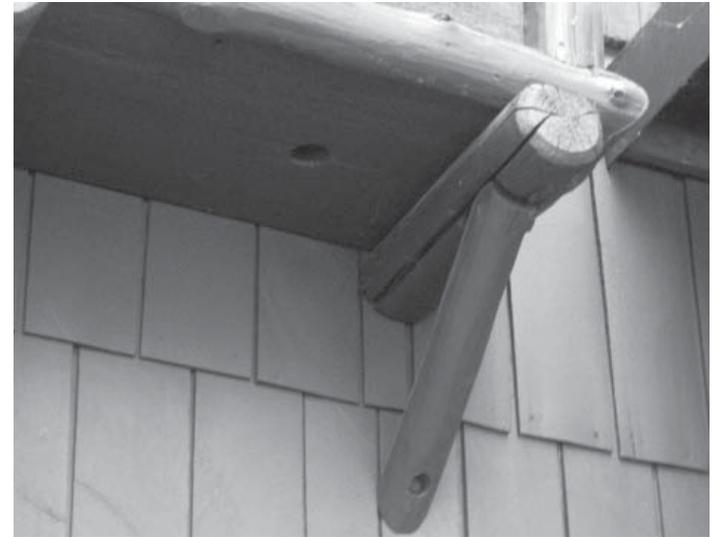
Figure 6.13: Above, water damaged log pilaster base, below, checked and split planter bracket. (Sommers, 2009)

The engaged columns are in fair condition. There is peeling paint on all of the columns. Most of the paint is at the base and thus can be water damage from rain and snow accumulation. The upper sections are due to extended weathering and exposure from the sun. Checking of the columns is also evident, which is common for cedar logs. Checking can also exacerbate peeling paint.⁶

Other problems, including insect borings and animal droppings, are present along the pilasters of the south elevation. Entire column sections have been replaced with new pieces. The northwest column of the entry has had its lower half replaced with a new log section which does not match the upper half. The column on the north gable has been repaired with a Dutchman at the base. The repairs are very obvious and a few appear to be failing.

The boxes along the south courtyard elevation are in poor condition. Water damage from roof above has rotted and damaged the boxes interior as well as the decorative logs. Wood planks cover the planters opening to keep water from collecting at the bottom, but this has also deemed unsuccessful at protecting the planters. On the south elevation, the planters are in poor condition as well. The boxes are separating at the corner exposing the interior box to more water infiltration. There is also paint peeling and chipping along the sides of the boxes. The Mather Suite and Dining Room boxes were rebuilt during the 1970s.

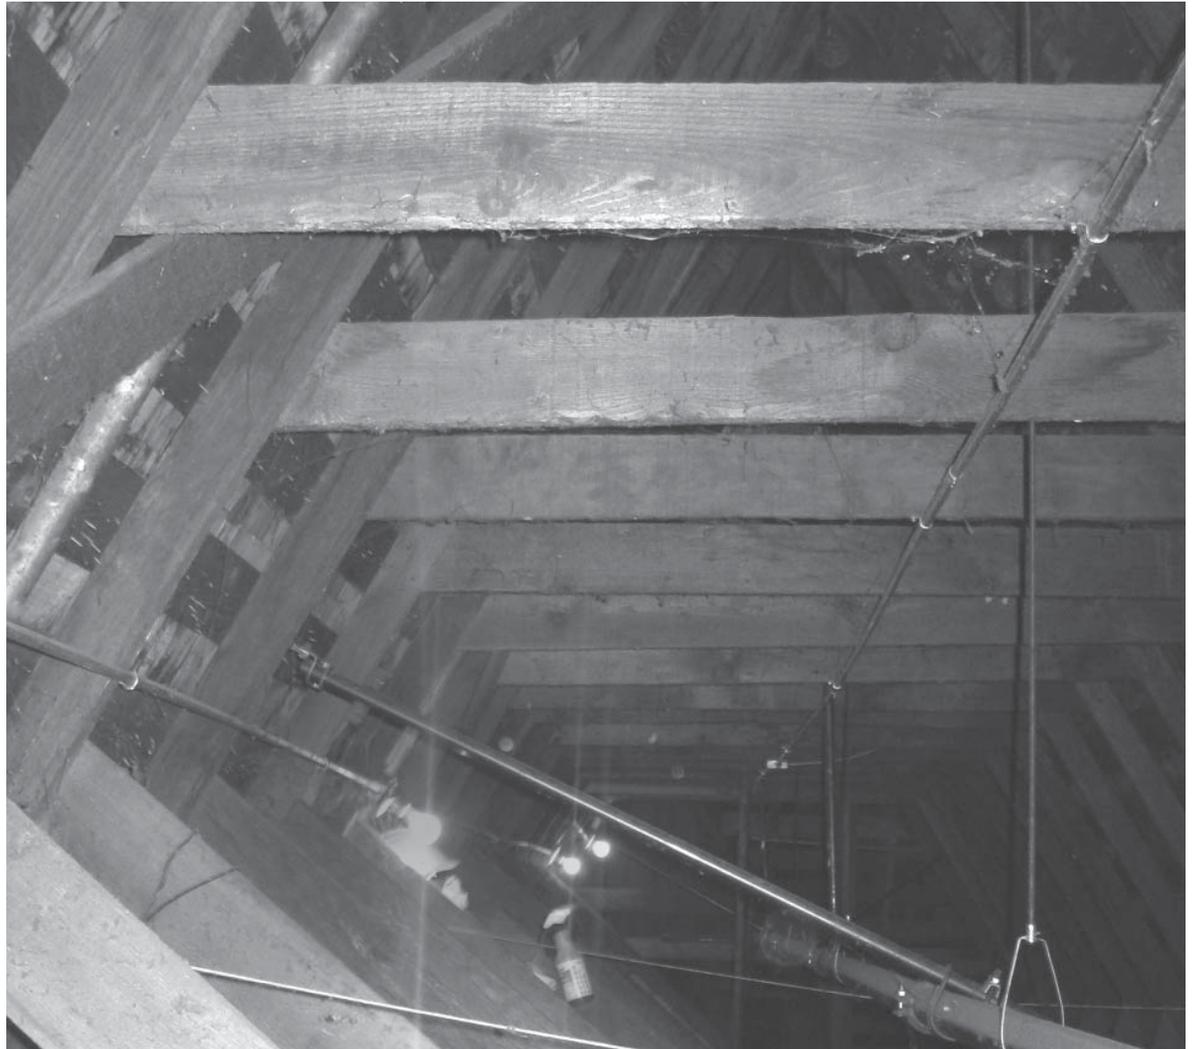
Figure 6.17: Attic view (Sommers, 2009)

The attic is very dirty with dust and cobwebs. Minor water staining is visible at the shingles. The metal mesh screens at the vents are not properly secured in place and the vent on the west wing gable end has a broken frame. The rock wool insulation is very uneven throughout the attic. A full size mattress is sitting on top of the ceiling joist and insulation in the southwestern corner of the attic and clothing items are located throughout the attic area. Rodent droppings were visible in several locations in the attic. Half the light bulbs do not work.

1. Remove duff from roof.
2. Repair or replace damaged shingles at base of dormers
3. Restore decorative cut and appropriate length for barge couple rafter tails on dormitory gable ends.
4. Replace damaged roof shingles.
5. Remove the mattress and clothing articles from the attic.
6. Replace non-functioning light bulbs.
7. Repair vent frame on the west wing gable end and secure all metal mesh in place on all vents.

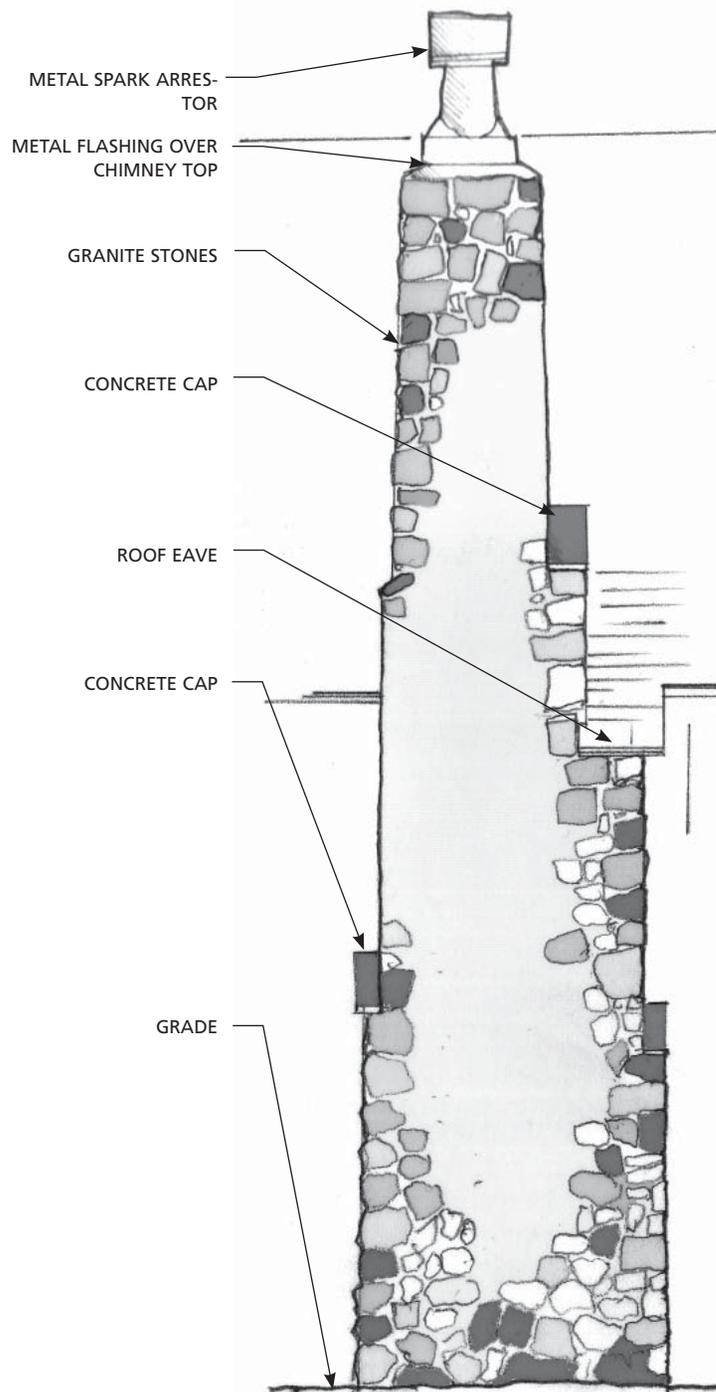
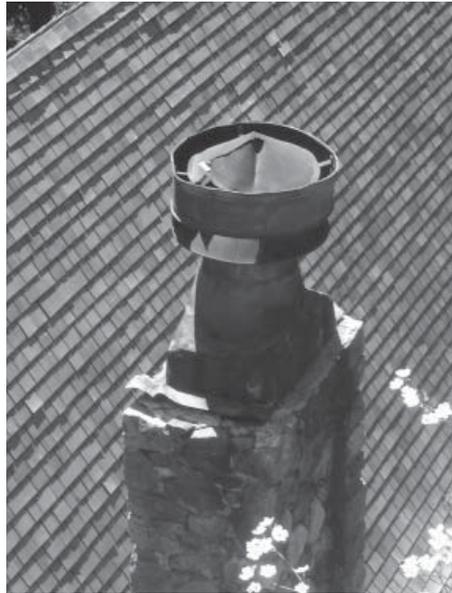
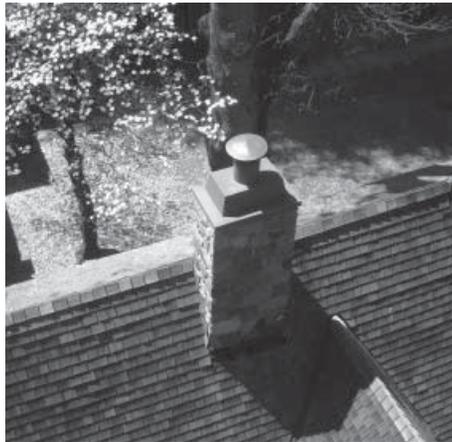
Figure 6.20: Chimney elevation drawing, above right, main chimney cap, below right, kitchen chimney cap (Drawing: Jaramillo, 2009, Photos: Humphrey, 2007)

The exterior of the chimney is in fair condition. Stains and efflorescence on the base are evident, probably due to snow accumulation and water migration. Poor repointing shows two different mortars along the west edge.

There is organic buildup at the chimney cricket as well as moss and staining on the east middle setback near the eaves. This is due to the closeness of the oak tree and pine needles falling from the trees nearby. The chimney cap is rusted and partially open allowing animals inside the clubhouse. On the interior, the firebox is dirty, but functioning.

1. Continue to monitor large crack in lintel of fireplace. Consult with masonry conservator concerning repair options.
2. Remove duff from cricket.
3. Repair damaged spark arrestor. Review with park architect will be required if replacement is necessary.
4. Repoint masonry with appropriate mortar mix.

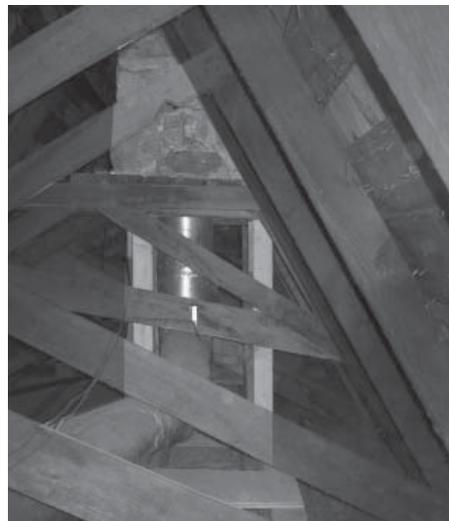
Figure 6.21: Left, interior stub of kitchen chimney supported by wood cribbing, right, organic growth from moisture retention on chimney (Jaramillo, 2009)

1. Consult with structural engineer experienced in treatment of historic buildings to assess stability of the kitchen chimney remnant and provide adequate support. Care must be taken to preserve the historic integrity of this character defining feature.

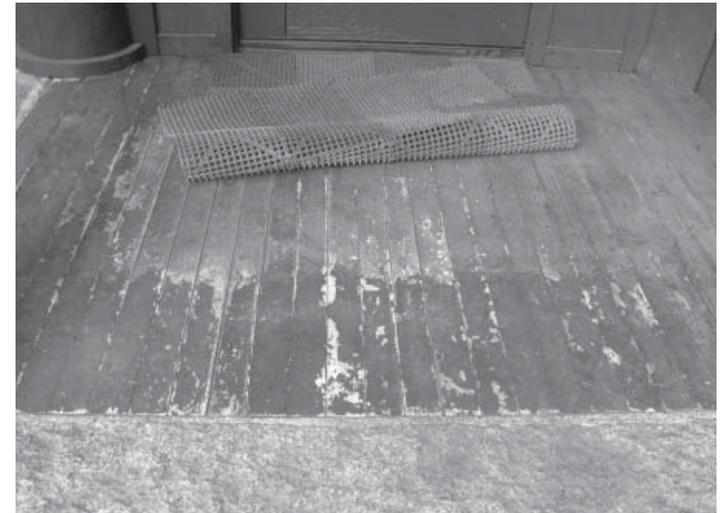
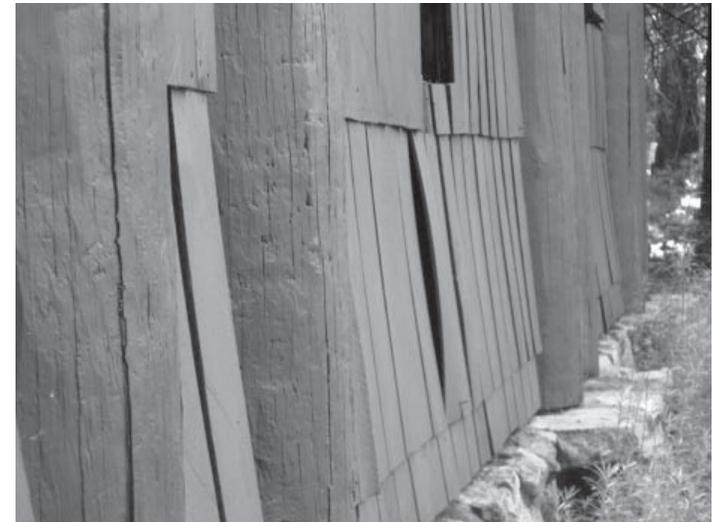
Figure 6.29: Clockwise, upper left, deteriorated deck on south terrace, below left, shed roof of service entry, middle, checked log column, upper right, damaged entry porch floorboards, lower right, damaged shingles on terrace. (Jaramillo, Sommers, Durbin, 2009)

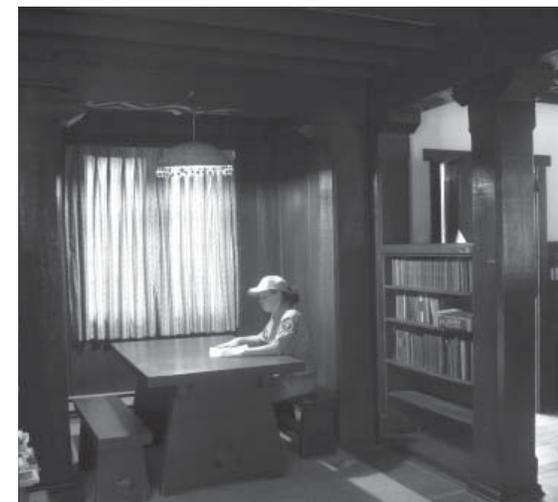
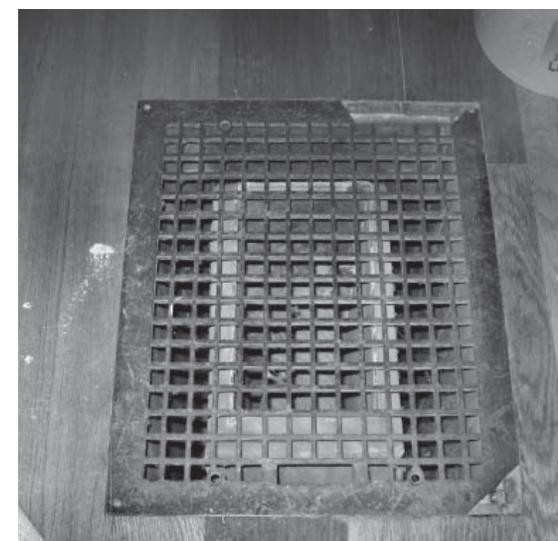
Figure 6.39: View of non-functioning floor register (Somers, 2009)

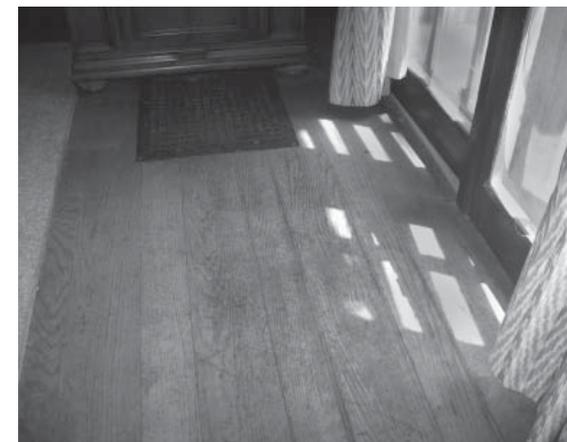
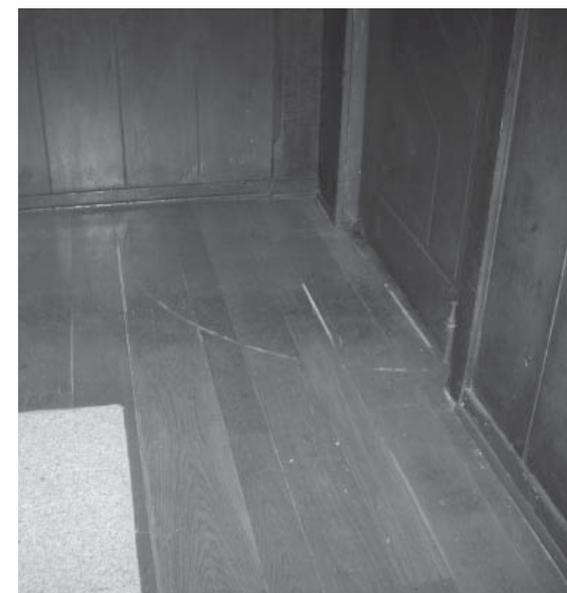
The oak floors in these spaces are heavily scratched, dented and stained. The floor has been patched in several areas with a different species of wood and a different stain was used. At the edges where the wood boards meet much of the wood has broken off. Where the doors open into the room the floors are worn and the finish is gone. The door stops are dragging on the wood floors leaving quarter circle grooves scratched on the floors near the doors. Under the carpets the finish is almost completely gone and there is heavy water staining. Residents report that the carpets are washed in place. The painted black finish on the older floor grates is worn and the heating grate in the dining room floor has a corner broken off.

Figure 6.43: Above, Damaged floor at terrace doors, below, damaged and scuffed floor at kitchen entry (Jaramillo,2010, Sommers, 2009)

1. Restore fireplace tool holder to position on granite stack on right side of firebox opening.
2. Paint the sheet metal duct, which is visible through unused floor grate, a dark brown color.
3. Refinish oak floor and repair or replace in kind damaged boards.
4. Replace shelves in bookcases that are too short. Match stain and finish with existing.
5. Replace missing pinecones on the two basket light fixtures.

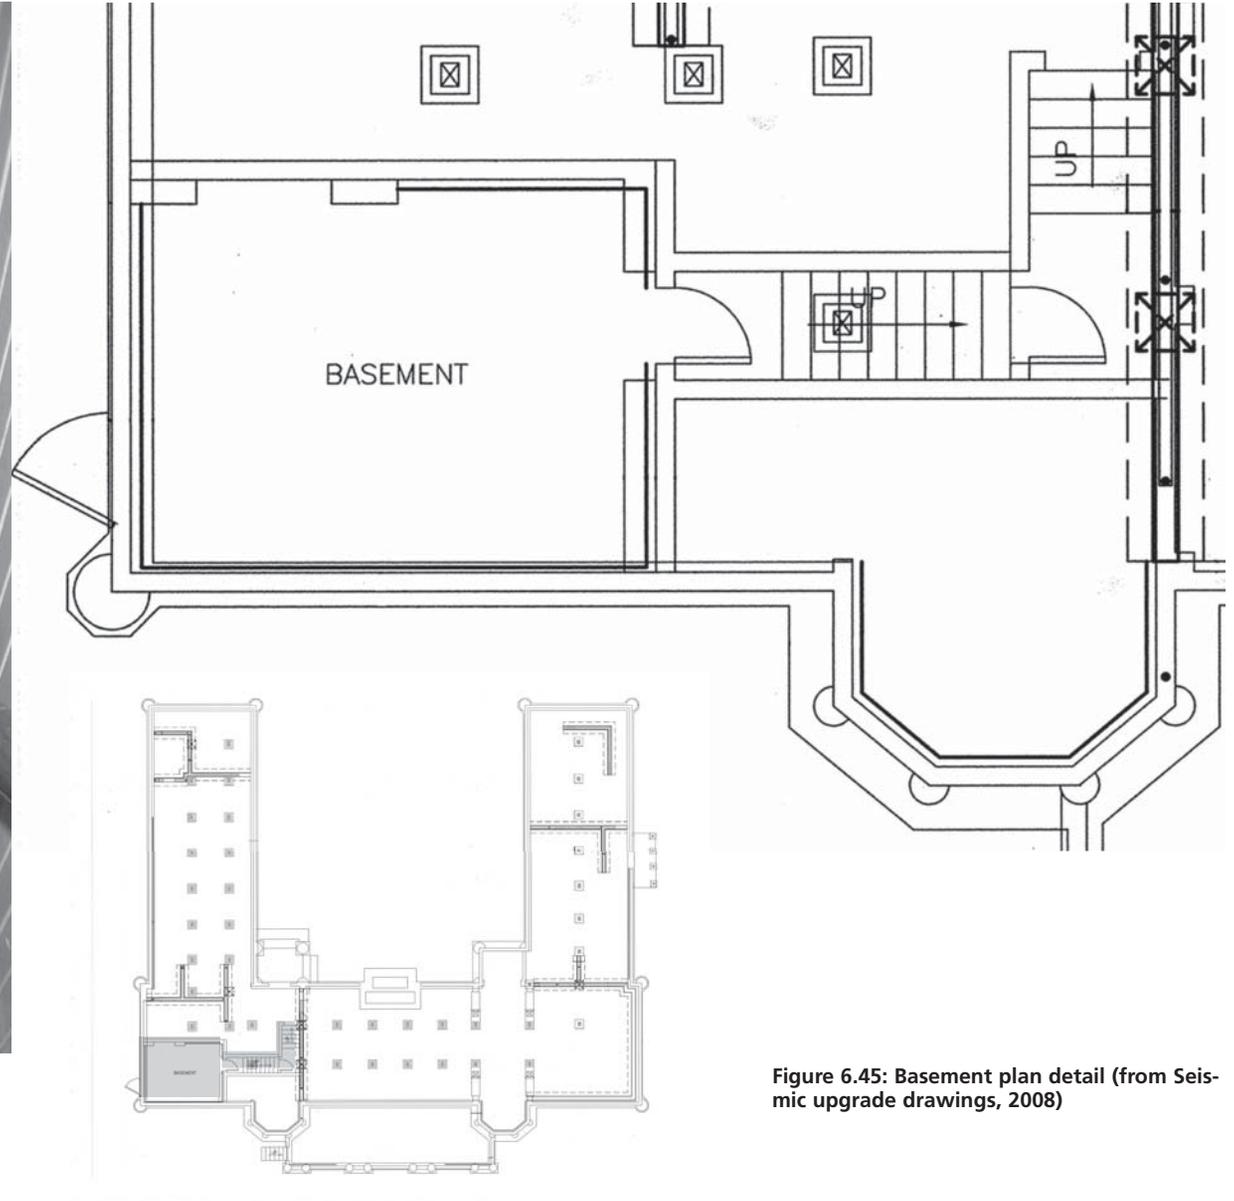
Figure 6.45: Basement plan detail (from Seismic upgrade drawings, 2008)

The plaster on the concrete walls is flaking off. Moisture is visible where the walls and floor meet around the room. The heater appears to be left on year round to help with the moisture in the basement, presenting a possible fire hazard since the heater is obviously not intended for this type of installation. All electrical, mechanical, plumbing and sprinkler systems in the basement are in fair to good condition. In this area there is an infestation of Pinacate beetles.

1. Moisture in the basement should be monitored.
2. Replace space heater at ceiling with a heater designed for this type of installation.

1. Control the moisture in the basement.
2. Remove or cover the special outlets for the laundry.
3. Refinish and repaint the lower portion of the walls.
4. Remove the remnants of old heating, plumbing and electrical systems.

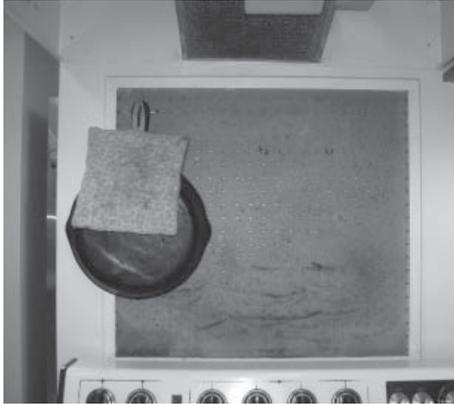
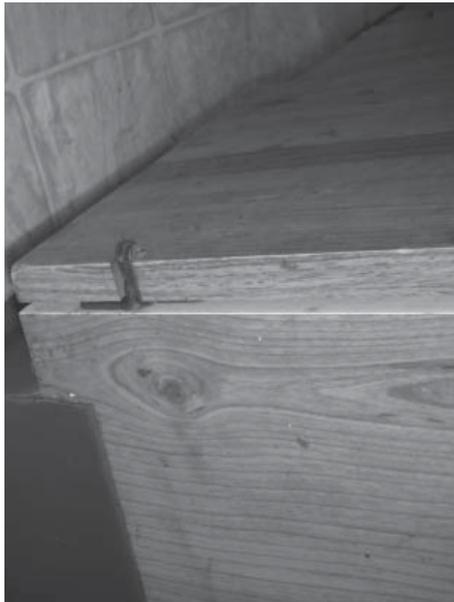
Figure 6.49: Above, corkboard above stove, below, damaged formica cabinet doors (Sommers, 2009)

The laminate countertops are heavily scratched in some areas. There is some discoloration on the surface of the countertops. The caulking at the backsplash and wall is discolored and cracking. The upper and lower cabinets are scratched and stained on the surface with some of the laminate chipping. Where labels have fallen off there is residue on the cabinets. The interior of the cabinets are scratched and stained.

1. Replace countertop and cabinets.

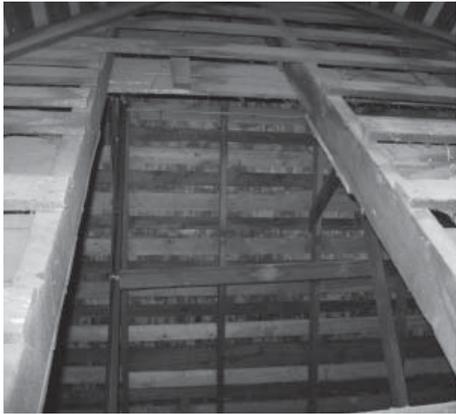
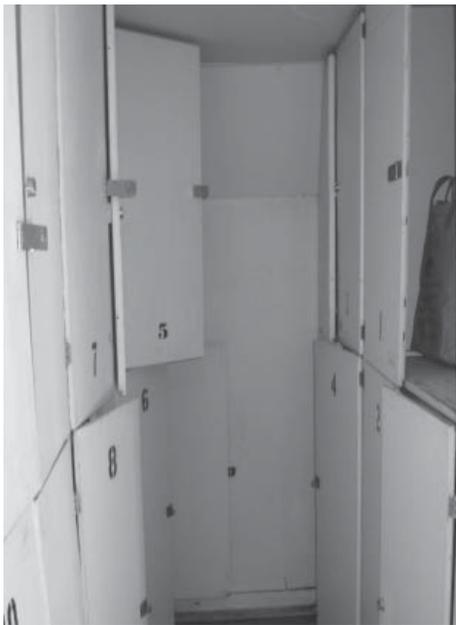
Figure 6.73: Above, garage attic roof structure, below, interior of storage room in garage building (Jaramillo, 2009)

On the roof a few wood shingles exhibit signs of warping and curling, but overall the roof is in good condition. The ridge of the roof shows signs of dipping and bowing, but not severe. The ridge cap is weathered but shows no moisture or odd discoloration. At the north and south gables vents are dusty, dirty, and cracking at edges. The gutter on the north-western corner is rusted, bent and has build up of leaves and debris. Skip sheathing has mild cracking and paint loss due to visible moisture damage.

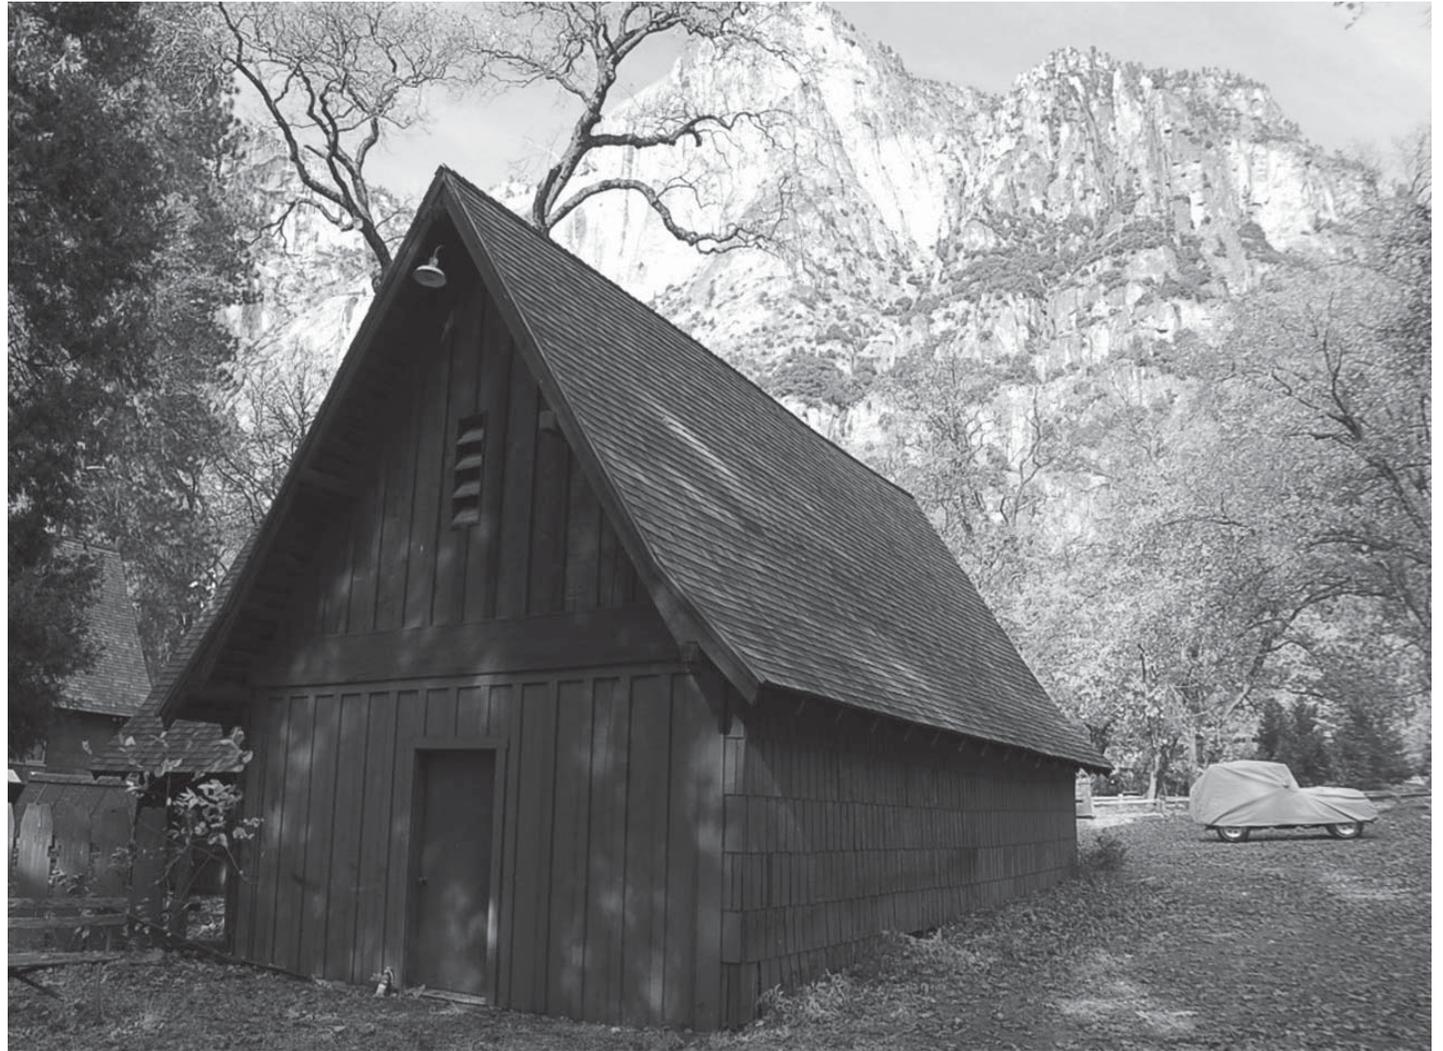
Figure 6.74: View of garge looking northwest with Yosemite valley cliffs in background (Jaramillo, 2009)

The foundation of the garage building is only partially visible due to build up of dirt and debris around the building. The lower shingles are extremely dirty due to the build up around the base of the building. There is evidence of moss, paint stains and moisture infiltration on the siding. The wood siding is cracking at nail heads, pieces are missing or splitting and paint is bubbling. Much of the damage is caused by the soil and debris build up. Many lower shingles are not visible, broken, missing, or covered in moss. The southern gabled side has two different colors of paint.

Throughout the building there are many electrical holes that have been drilled into the siding. Some of them have unused or cut wires protruding from the holes.

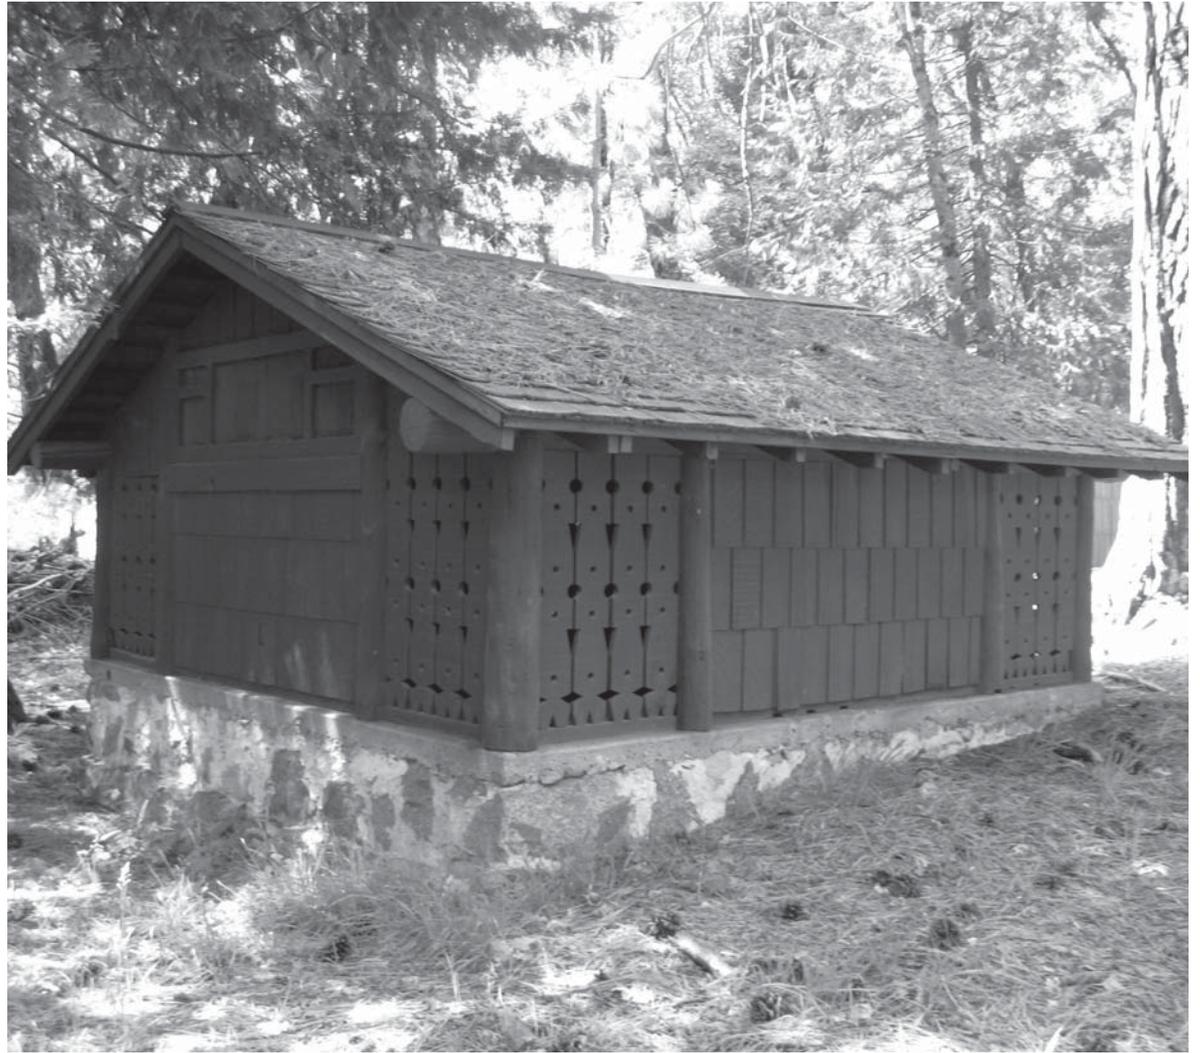
Figure 6.78: Northwest view of transformer building (Jaramillo, 2009)

The masonry of the foundation has been poorly repointed. On the southwest corner the decorative board siding is missing, cracked and split. The door is missing a lock. Roof has plant debris accumulation and minor sagging.

On the interior there is moisture build up on the concrete slab. There is also obvious damage from pest infestation.

1. Repair or replace decorative siding in kind
2. Secure door
3. Clear roof of debris
4. Repoint foundation
